Manhole Inspection Summary

Manhole # S25EE1029MH

Location Address: **3834 HICKORY AVE**

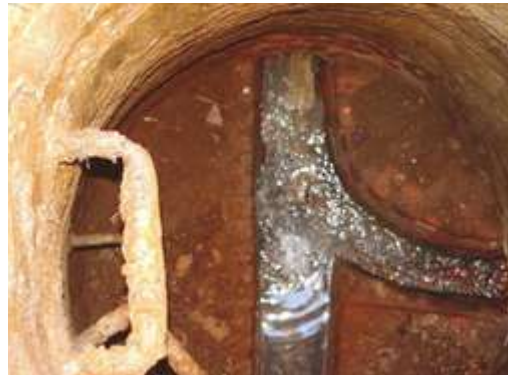
Top View

Corroded steps. Evidence of surcharge - Bench debris. Channel debris.

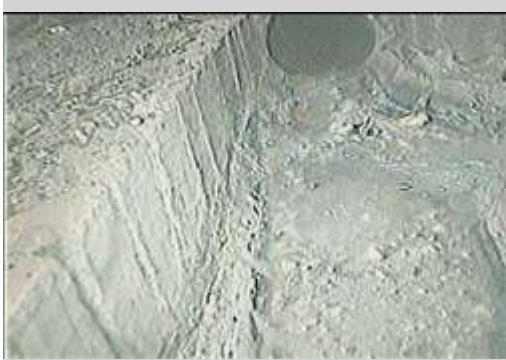
Defect

Channel deterioration and root intrusion.

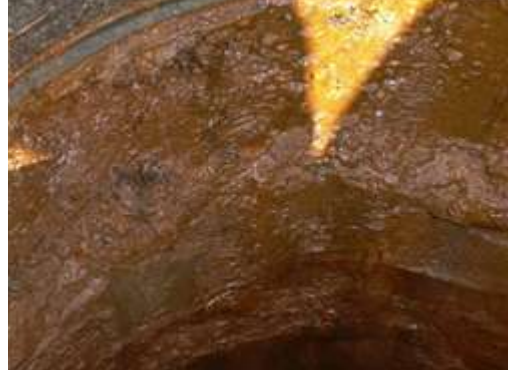
Defect

Frame leaks. Adjustment infiltration.

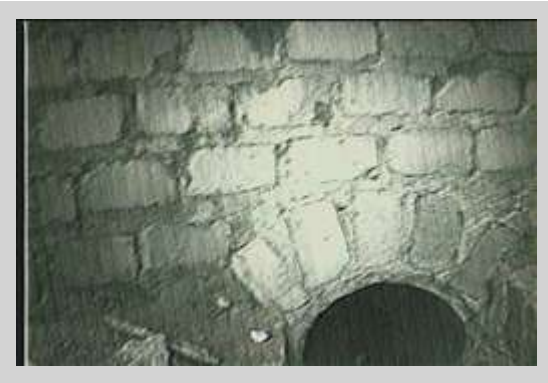
8 in. Circular Gravity Sewer Pipe Out @ 12 O'Clock

Barrel deterioration and infiltration.

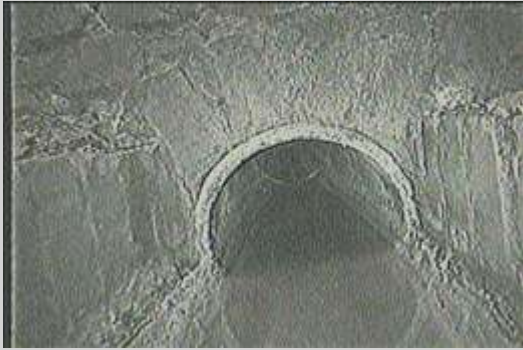
Pipe In @ 6 O'Clock

Barrel deterioration and infiltration. Channel deterioration.
